点検結果一覧

2.4 点検結果写真

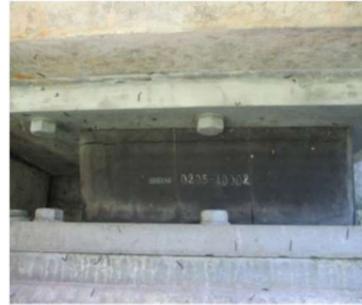
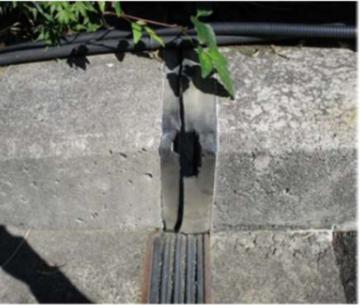
橋梁番号	橋梁名	供用開始年月	供用年数	路線名	径間数	橋長	部材単位の診断結果					健全性の診断	コメント	
							上部構造			下部構造	支承部			その他
							主桁	横桁	床版					
12	鳴子坂橋	1990	30	林道萌出線	3	58.7	I	/	I	I	/	/	I	特になし
13	新鳴子坂橋	1999	21	林道萌出線	3	55.8	I	/	I	I	/	/	I	特になし
14	寺ノ沢橋	2002	18	林道寺ノ沢線	2	96.7	I	/	I	I	II	/	II	支承:変色・劣化(ゴム・プラスチック)

TRNS_3495.jpg 支承:Bh0101e 健全度 3.0	TRNS_0099.jpg 防護柵:Gf0101 健全度 4.0

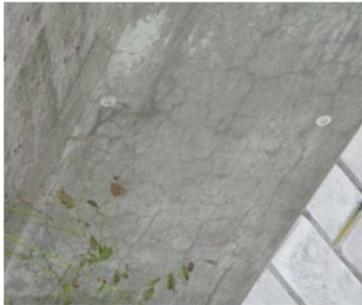
NARU_0074.jpg 床版(Co):Ds0102e 健全度 4.0

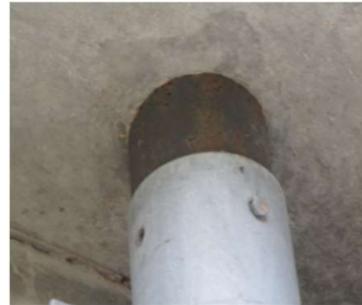
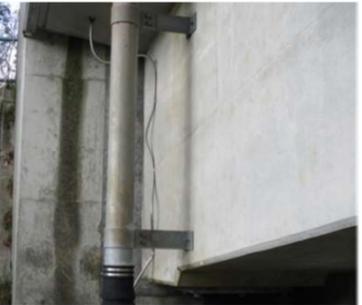
TRNS_1294.jpg 排水管:Dp0101 健全度 4.0	TRNS_1301.jpg 橋台胸壁:Ap0101e 健全度 4.0
		NARU_1205.jpg ラーメン主構(脚):Rp0102 健全度 4.0			SNAR_0166.jpg 排水ます:Dr0201 健全度 4.5
